MISCELLANEOUS PAPER S-73-45

CONDITION SURVEY, WHITEMAN AIR FORCE BASE, MISSOURI

P. J. Vedros, S. J. Alford

June 1973

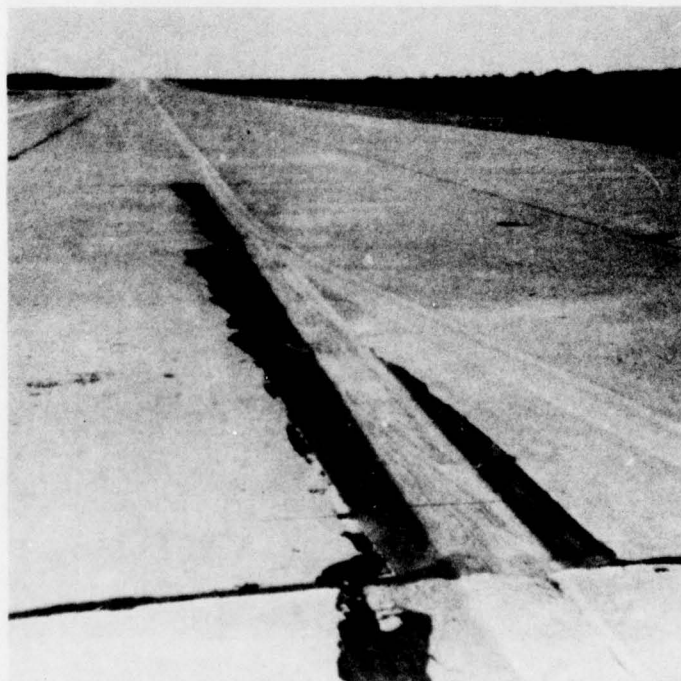
defect, and a majority of the slabs contained pop-outs. The center lane of the taxiway contained most of the major defects, and the most common defect was longitudinal cracking adjacent to the center line (photo 2). There has been a progression of this longitudinal cracking from 10 slabs in 1960 (based on the 1960 condition survey, paragraph 6) to 16 slabs in 1972. Slabs containing pop-outs have increased from 111 in 1960 to 581 in 1972.

Photo 2. Patched longitudinal crack on taxiway 11A

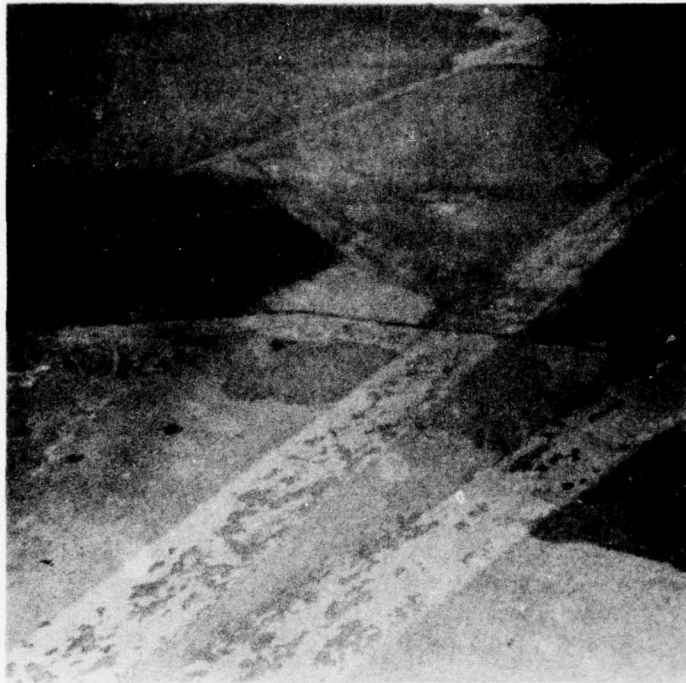
Photo 3. Water seepage through joints in apron

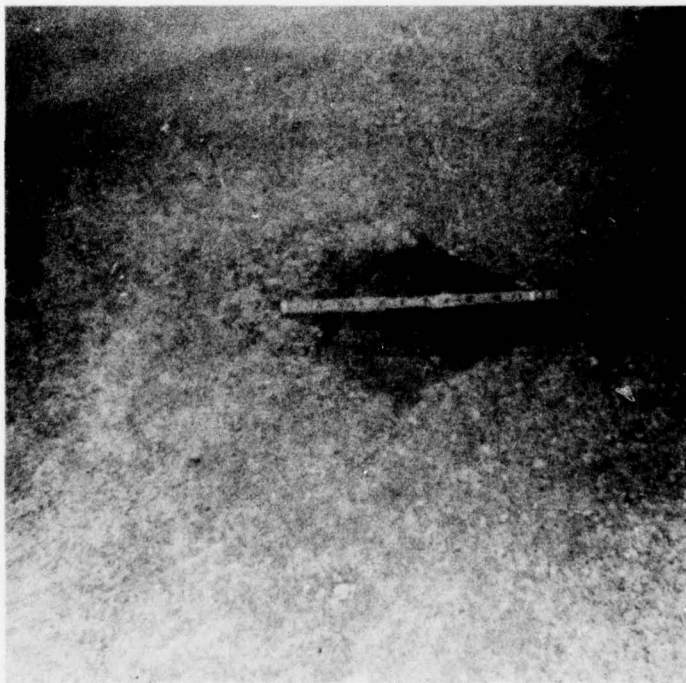
Photo 4. Pop-out on apron area

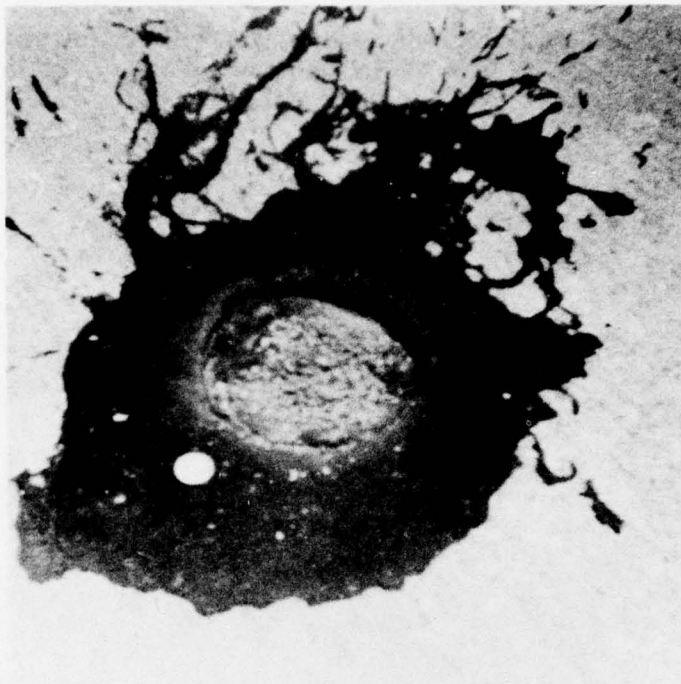
25. The north warm-up apron (feature A11B), which is 18-in.-thick pavement, was in very good condition. However, every slab contained pop-outs (photo 5), and a few slabs contained spalls. The shoulder pavements adjacent to the north warm-up apron were in fair condition, with transverse cracks and open paving joints apparent (photo 6). In the south warm-up apron (feature A10B), which is 17-in.-thick pavement, only about 4 percent of the slabs contained major defects. However, every slab had evidence of "D" cracking (photo 7), and approximately 34 percent of the slabs had spalls that had been repaired. The east warm-up apron (feature A9B), which is 18-in.-thick pavement, was in very good condition; however, every slab contained pop-outs, and a few slabs contained spalls.

Photo 5. Repaired pop-out on north warm-up apron

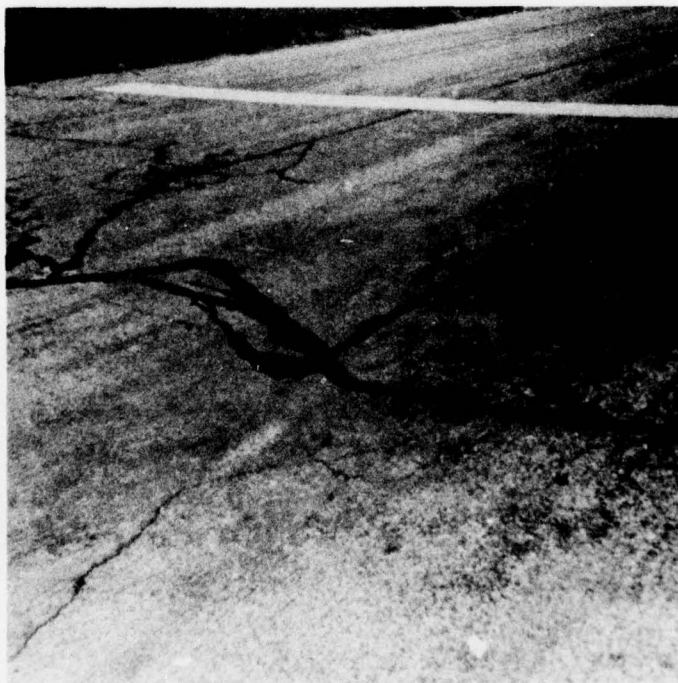
Photo 6. Condition of shoulder area adjacent to north warm-up apron

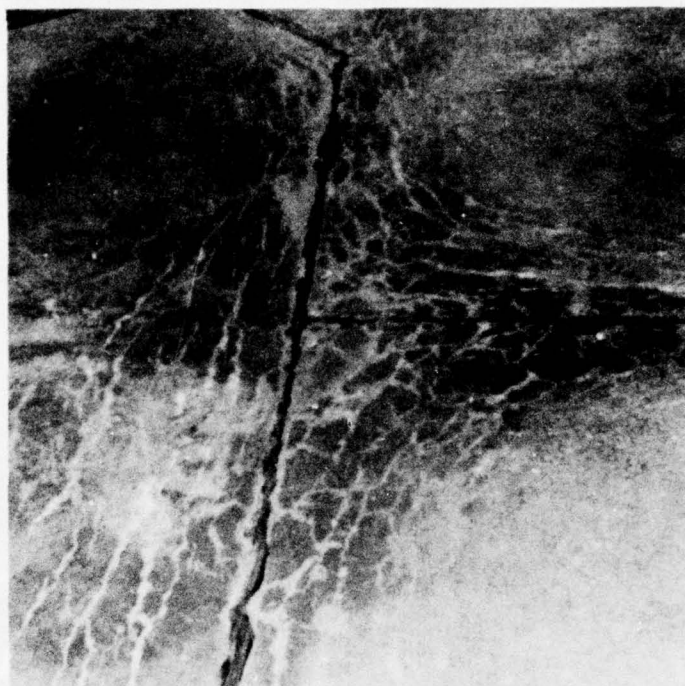
Photo 7. Severity of "D" cracking on south warm-up apron

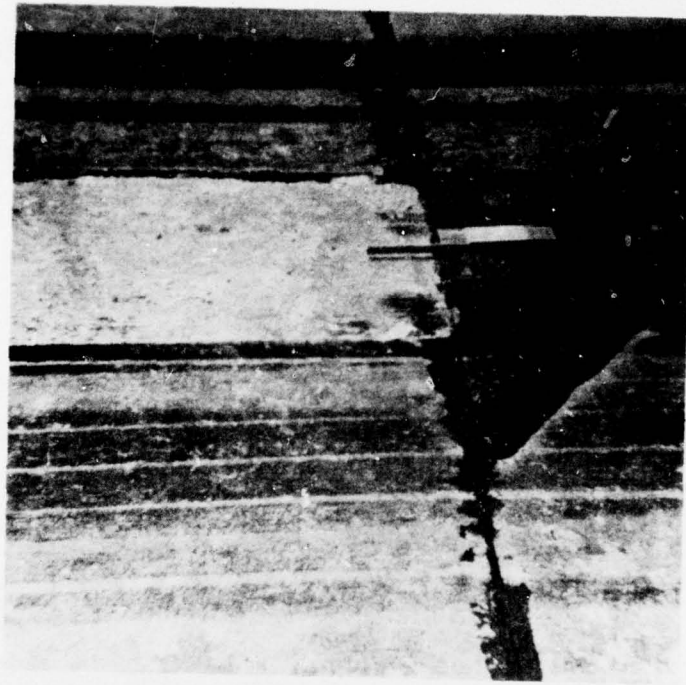
42. Based on the 1972 survey, pop-outs and spalling along joints constitute the major maintenance problems at WAFB. Pop-outs were found in most of the pavement features, as is indicated in table 4, with especially high concentrations observed in the parking apron. "D" cracking was prevalent at several locations and constituted a serious problem on the south end of the alert apron, taxiways 1, 2, 16A, and 16B, the south end of the runway, and the south warm-up apron where cracking had progressed (or soon will progress) to the point that scaling and spalling will occur. The spalls have been patched with epoxy and mortar, bituminous cold mix, or PCC with epoxy bonding. In some cases, they have been sealed with joint seal material (photos 10 and 11).

Photo 11. Epoxy patches of spalls with and without
joint seal
